# Manhole Inspection Summary

Manhole # S49EE\_043MH

**Location** Address: **milton st**

Cross Street: **eager st**

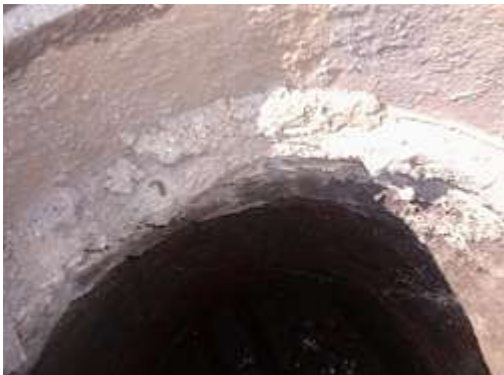
Defect 2

**Frame** Offset: **1** (in.) Condition: ☐ Sound ☐ Cracked ☒ **Leaks**

Frame leaks

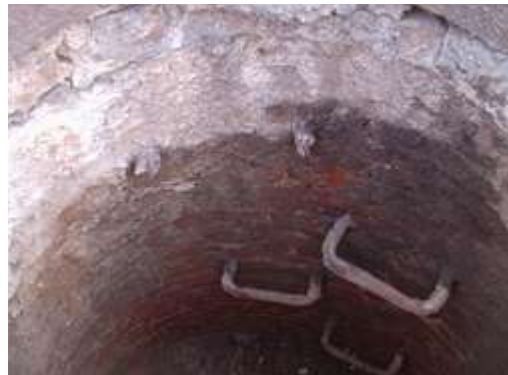
Defect 1

Infiltration: ☐ None ☒ **Joint** ☐ Cracks ☐ Mortar ☐ Roots ☒ **Wall**

Infiltration

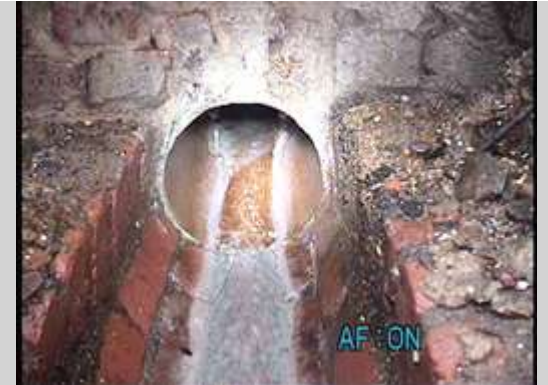
12 O'Clock Outflow

8 in. Circular Gravity Sewer  
Pipe Out @ 12 O'Clock

Pipe Height: **8.4** (in.) Rod and Bar (Angled)  
Pipe Material: **Clay** ☐ Pipe Lined  
Invert Depth: **7.90** (ft.) Flow Characteristics: **Slow**  
Deposits: ☒ None ☐ Mud ☐ Sludge ☐ Debris ☐ Grease  
Silt Depth: (in.) Deposits Extent:  
Infiltration: **None** Pipe Seal Cond: **Sound**

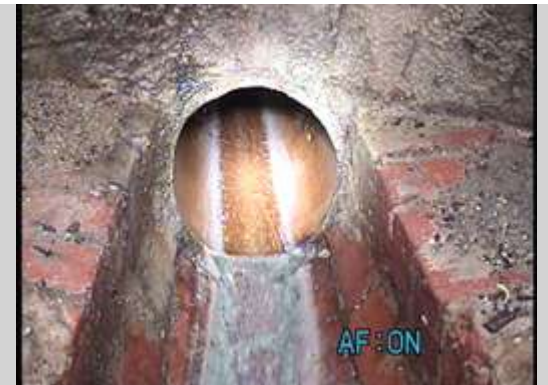
6 O'Clock Inflow

8 in. Circular Gravity Sewer  
Pipe In @ 6 O'Clock

Pipe Height: **8.4** (in.) Rod and Bar (Angled)  
Pipe Material: **Clay** ☐ Pipe Lined  
Invert Depth: **7.70** (ft.) Flow Characteristics: **Slow**  
Deposits: ☒ None ☐ Mud ☐ Sludge ☐ Debris ☐ Grease  
Silt Depth: (in.) Deposits Extent:  
Infiltration: **None** Pipe Seal Cond: **Sound**
